INZ76111-01		
Client:	Fastmount	Limited			
Order No.:	PO0595 VL (Very Low Profile) Range				
ample Description:			12V Ratch No. 05006		
dentification:	vL-F3H Batch No: 26821 VL-M3X Batch No: 25836 n: Acetyl / Nylon GF				
laterial Specification: ested in accordance with:		As per method statement			
Test: Repetitive system.	pull-out load test (Fig.	2) and a shear test (l	Fig. 3) on the VL Rar	ge plastic mounting	
Method: Repetitive	<u>pull-out test</u>				
of approxin	mately 1 cycle per 15s 500 cycles. Graphica	. The initial pull-out fo	rce was measured a		
<u>Shear test</u>					
	rce was applied to the emale clips through th			paration between the	
	Test Conditions -	23 ± 2ºC			
Results:					
Female / Male	Pull-out F	orce (Kgf)	Shear Force (Kgf	) Comments	
Clip	Initial	After 500 Cycles			
VL-F3H / VL-M3X	41.5	12.9	121.4	Refer to fig. 4 and fig. 5 for photograph depiction of wear and shear outcome	
	VL-F3H			/L-M3X

TEST REPORT No.: INZ76111-01

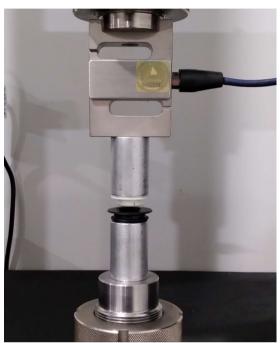
Figure 2 - Pull-out cycling

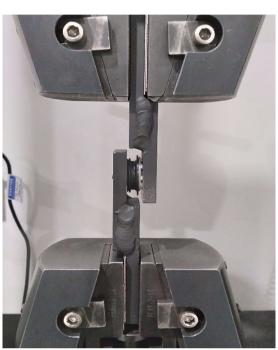
Figure 3 - Shear test setup

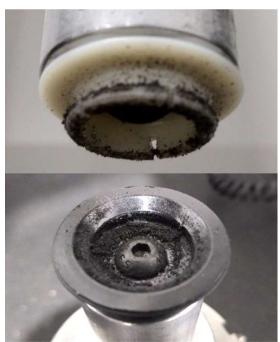
Figure 4 - Pull-out test after 500 cycles

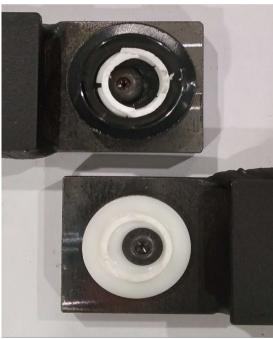
Figure 5 - Shear test after failure

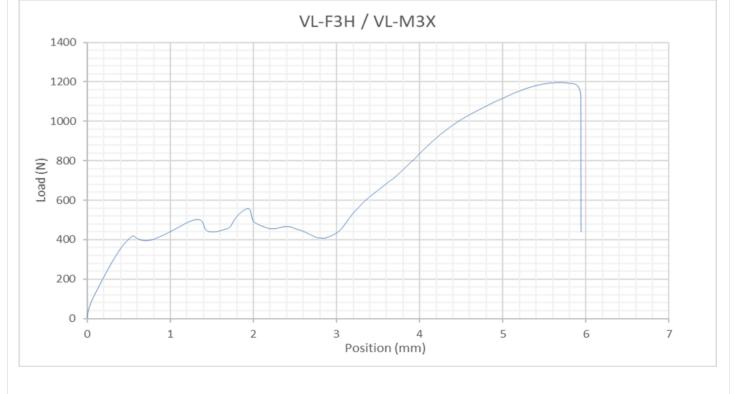
Graphical representation of shear behaviour

## TEST REPORT No.: INZ76111-01 Appendix A Graphical representation of pull-out behaviour over 500 cycles VL-F3H / VL-M3X (N) 250 200 200 Time (s)
