Study Report

SR462 [2021]

# Comparative study of corrosion rates in vented and unvented roof cavities

## BRANZ Study Report SR462

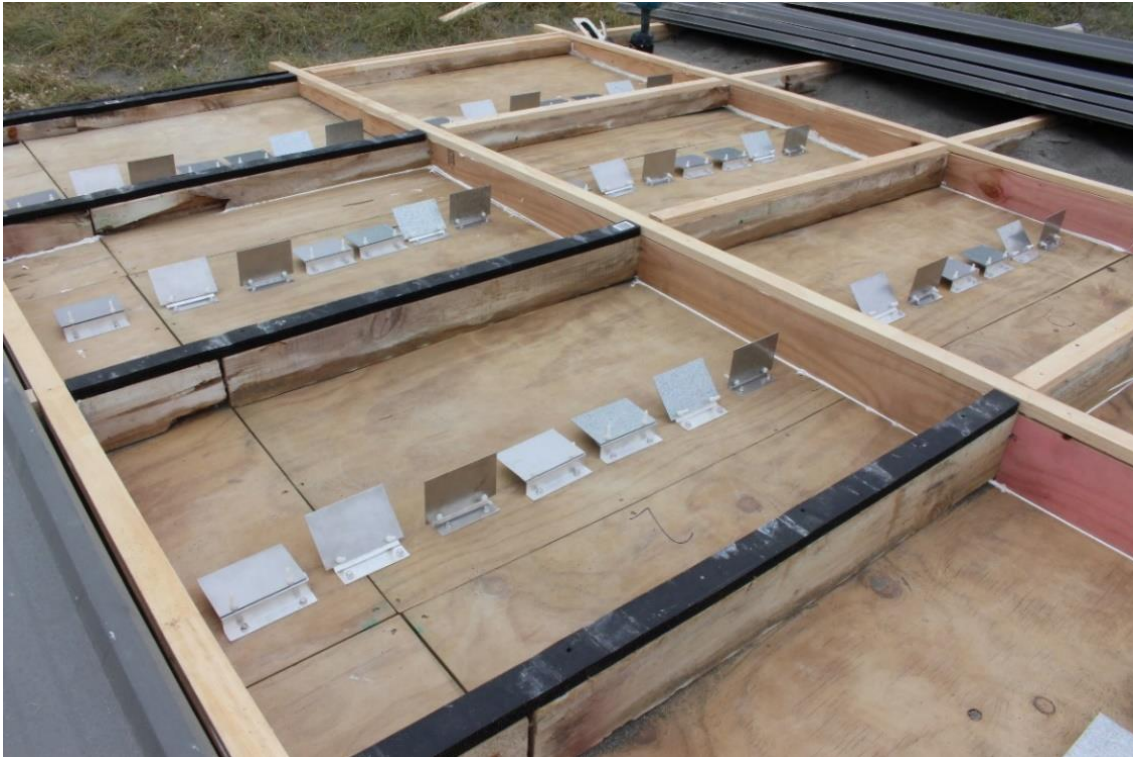
**Figure 2. Vented and unvented roof cavity of the test structure with metal coupons already in place.**

The structure underneath the plywood panels was more or less open to the outside environment (Figure 2). Both the vented and the unvented cavities were further separated into four bays. To minimise air exchanges between the two experimental cavities as well as air exchanges from each experimental cavity to the uncontrolled space on either side, care was taken to seal any gaps and openings.

The roofing underlay (not installed yet in Figure 2) was glued to the three relevant rafters, further minimising undesirable lateral air exchanges between the cavities.

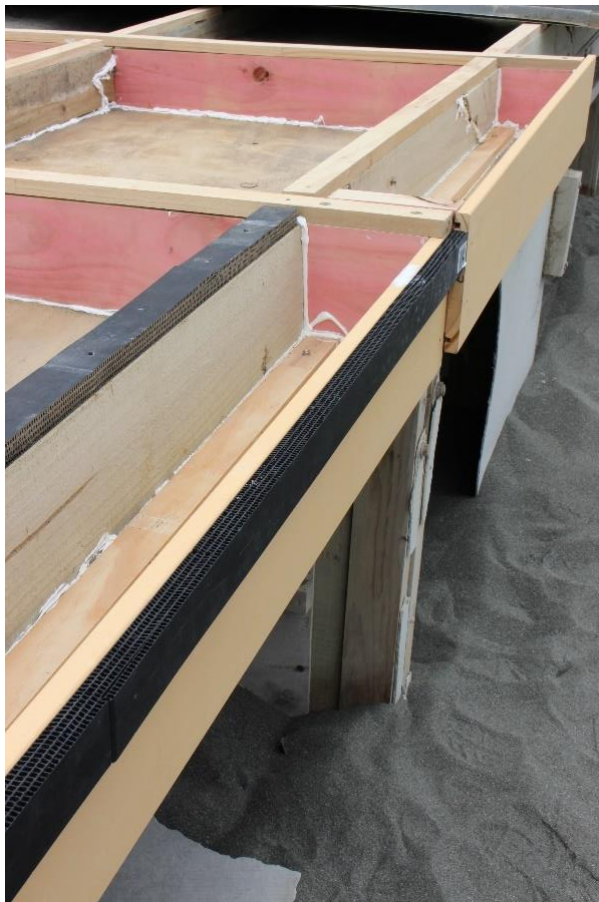
**Figure 4. Vent opening on the seaward side of the structure.**

The seaward side of the cavity had an additional vented batten mounted on the fascia board (Figure 4), which was then covered by the ridge flashing.

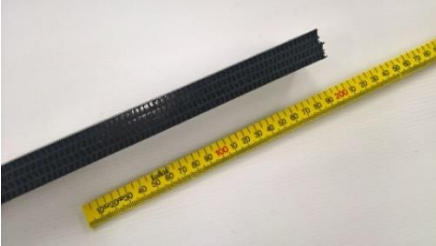
<b>Vented batten</b> $t = 20 \text{ mm}, d = 45 \text{ mm}, l = 1 \text{ m}$

$Q \text{ [l/s}\cdot\text{m]} = c \cdot \Delta p^n$	5.12	0.629
<b>Over-fascia vent</b>

The serial resistance of the installed vents to a mostly pressure-driven air exchange throughout the vented roof cavity is made up of six vented battens and one over-fascia vent element. The performance of the individual vent elements has been tested in our laboratory (Table 1). The airflow rate  $Q$  as a function of the pressure difference across the material is described by the leakage function (ASHRAE, 2009, Chapter 16, Equation 40):

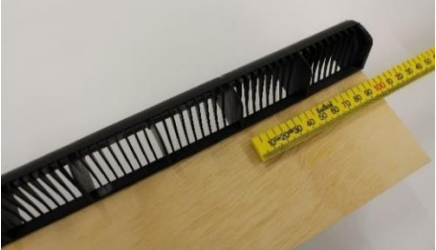
$Q \text{ [l/s}\cdot\text{m]} = c \cdot \Delta p^n$	14.32	0.504

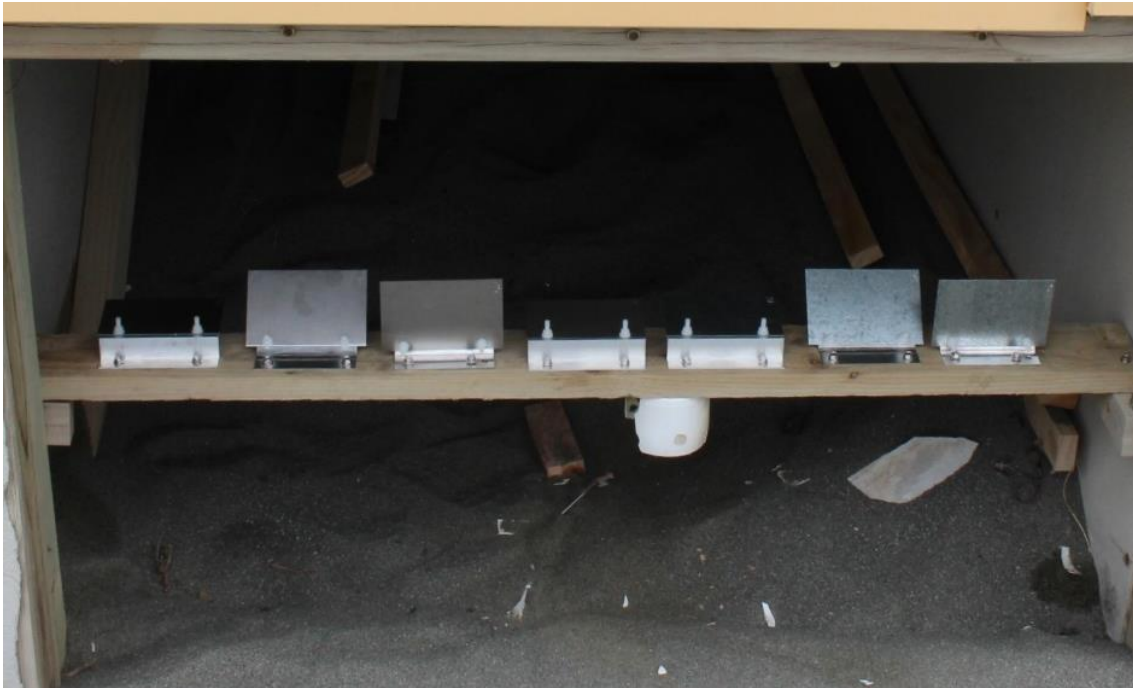
**Figure 7. Reference samples mounted in place.**

In total, there were 12 galvanised and 12 mild steel samples in each vented and unvented cavity. The position and orientation of each coupon is illustrated in Table 2. Stainless steel samples were also placed inside the structure. However, no corrosion rate could be reliably measured on those and no results are given in this report. Reference samples were installed outside the roof cavities – three mild steel and three galvanised steel samples in the same horizontal, 45° and vertical orientations as inside the roof cavity. A horizontal stainless-steel coupon was also installed for reference (Figure 7).

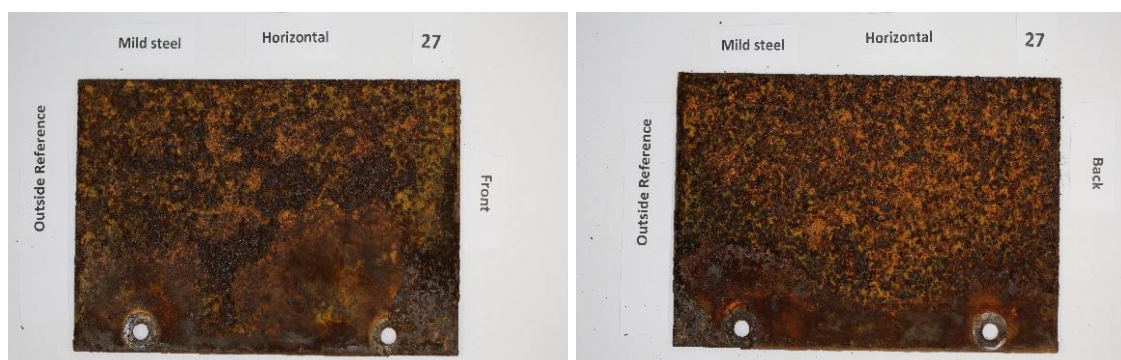
**Figure 8. Mild Steel reference sample 27 (horizontal) after 1 year – front and rear .**

As expected from previous work, the atmospheric first-year corrosion rates on the reference samples outside were extremely high. Figure 8 and Figure 9 show images of the outside reference sample (front and rear) that was installed horizontally. The nomenclature is such that, for the 45° and horizontal samples, 'front' means facing upwards, while for the vertical samples, 'front' means facing the seaside. The significant corrosion of the mild steel and iron oxide-hydroxide (red rust) can be seen. Corrosion is also visible on the galvanised coupons, especially around the perimeter where small spots of red rust are visible – a clear sign that the protective layer has been removed. The visual appearance of corrosion is very similar for all the outside samples on the front and the rear side.

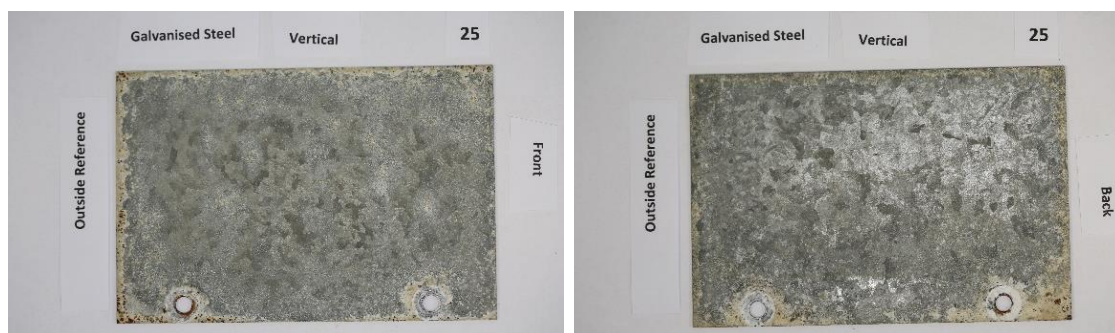
**Figure 9. Galvanised steel sample 25 (vertical) after 1 year – front and rear.**

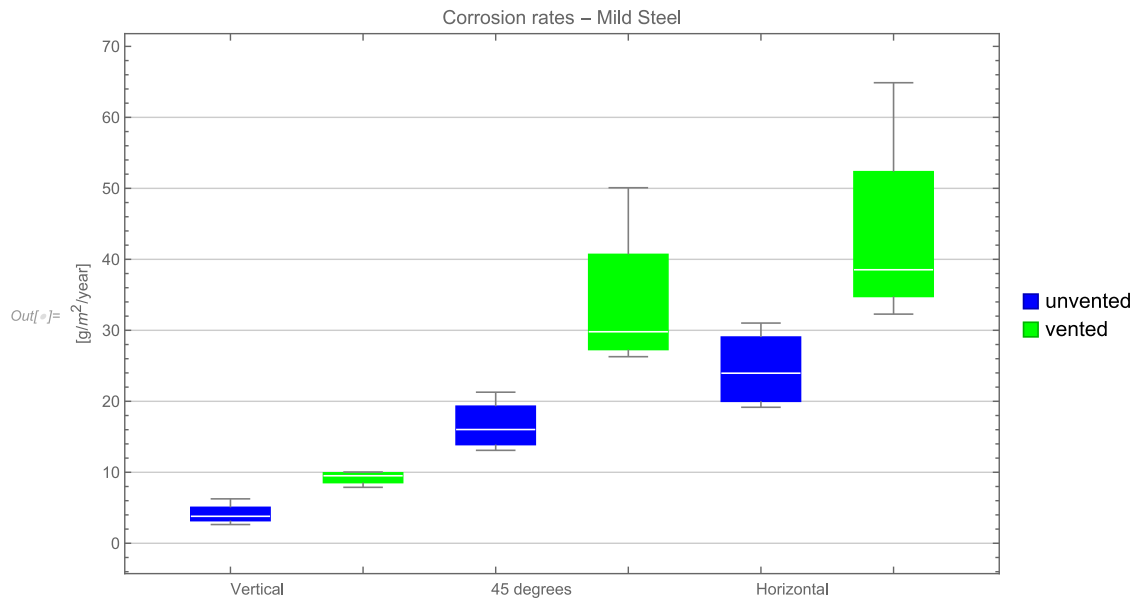
**Figure 10. Corrosion rates for all mild steel samples at the various orientations inside the roof test structure.**

Looking first at all samples in the vented and unvented cavities irrespective of their position in a particular bay, we find a consistent picture. The corrosion rates of the mild steel samples for all orientations (vertical, 45° and horizontal) are above the respective rates for the unvented cavity. Furthermore, the corrosion rates are highest for the horizontal samples, followed by the 45° coupons. The vertical samples for both the vented and the unvented cavities exhibit the lowest rates. These results are plotted as box-whisker<sup>3</sup> plots in Figure 10. The white horizontal bar indicates the median value and the upper and lower limits of the box represent the 75% and 25% quartiles, while the whiskers give upper and lower extreme values.

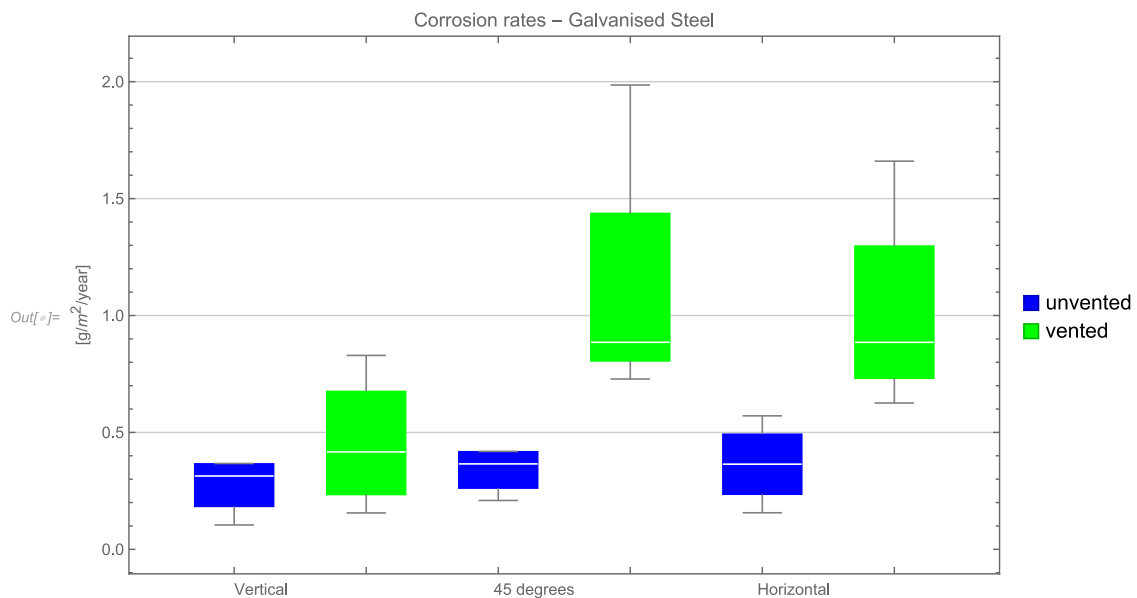
**Figure 11. Corrosion rates for all galvanised steel samples at the various orientations inside the test structure.**

A similar pattern is obtained for the galvanised steel samples. The corrosion rates of all orientations in the ventilated cavity are higher as compared to the unvented cavity. While again the vertical samples in both cavities show the lowest corrosion rates, there is no significant difference between the 45° and the horizontal samples in the vented and unvented space (Figure 11).
