# COMMERCIAL TRIMRIB ROOFING HEAD BARGE GIRTS BETWEEN COLUMNS (Notched - Birds Beak)

DETAIL NO. CTRO04B  
DATE DRAWN 16/08/12  
FILE REFERENCE RI-CTRO04B.DWG

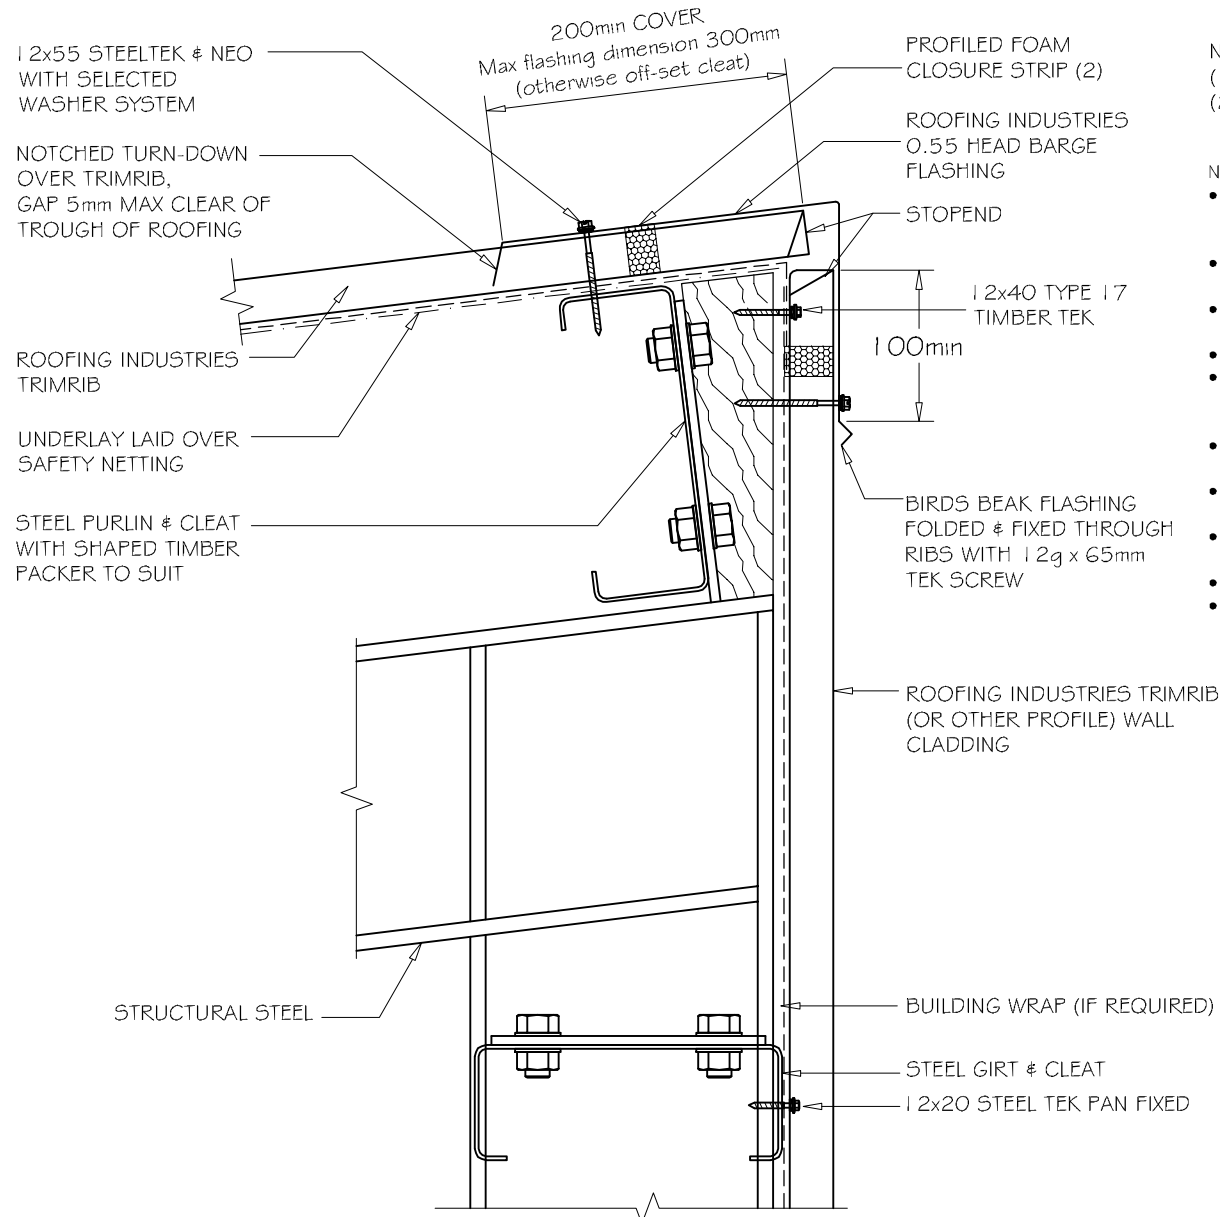
B HEAD BARGE  
- 1:5

- (1) MINIMUM PITCH 3°
- (2) FOAM CLOSURE STRIP ONLY REQUIRED IN HIGH RISK SITUATIONS OF WIND BLOWN MOISTURE ENTERING.
